Cold Creek at High Meadows Stream Channel and Floodplain Restoration Project

Second Year Post-Project Monitoring Report

February 2015

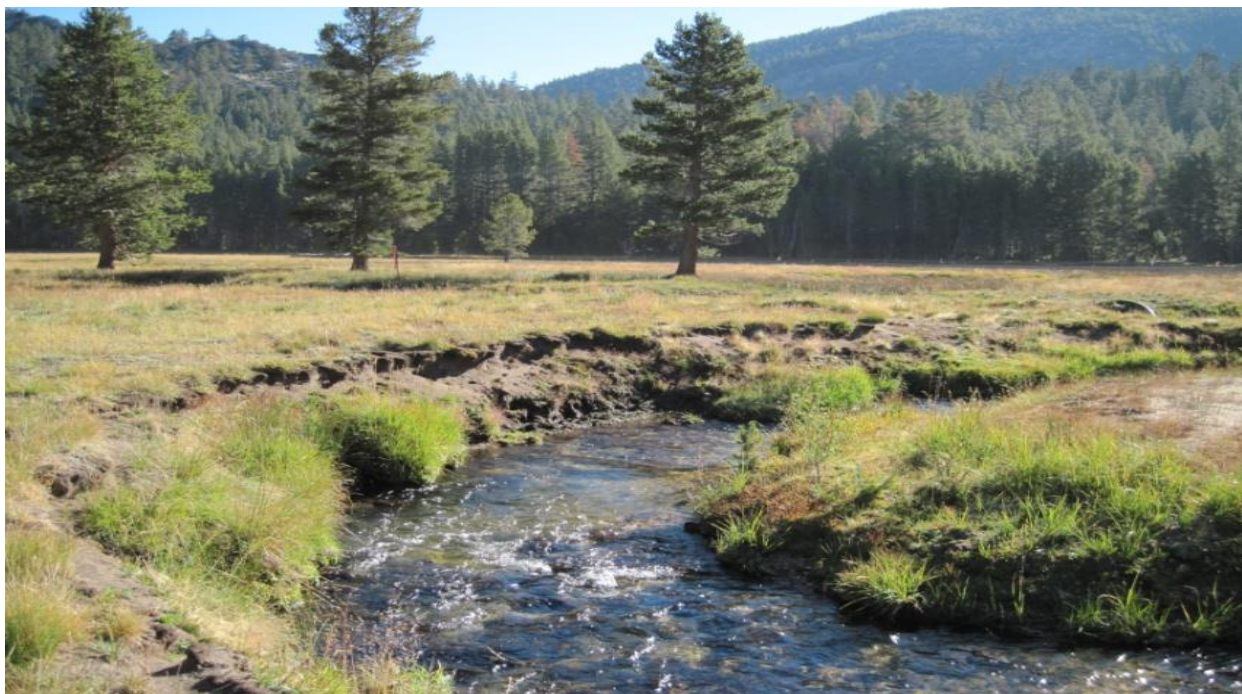
Figure 1: Cold Creek in High Meadows, 2004

This landscape had been highly altered and degraded since the mid-nineteenth century, primarily from 100 years of cattle grazing and associated diversion ditches. This led to down cutting and widening of the stream channel, lowered groundwater table in the meadow, leading to conversion to dry meadow species and lodge pole pine encroachment into the meadow.

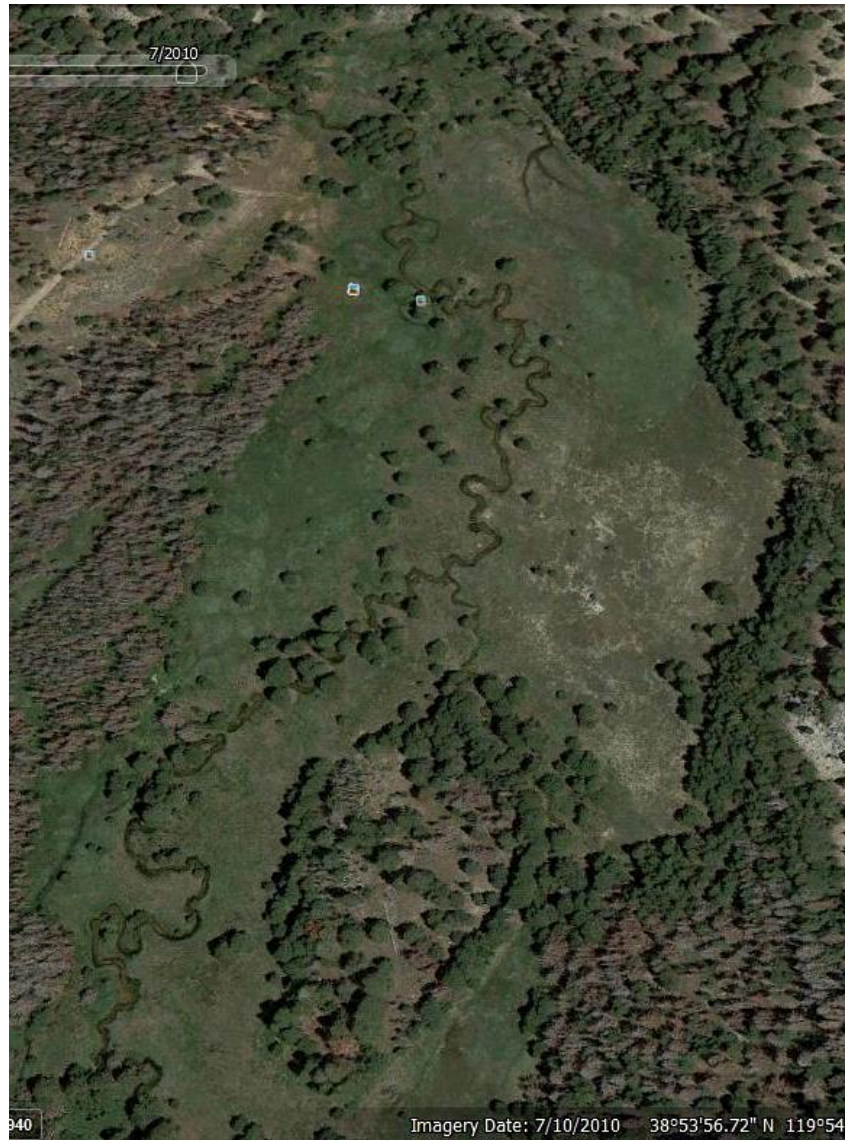
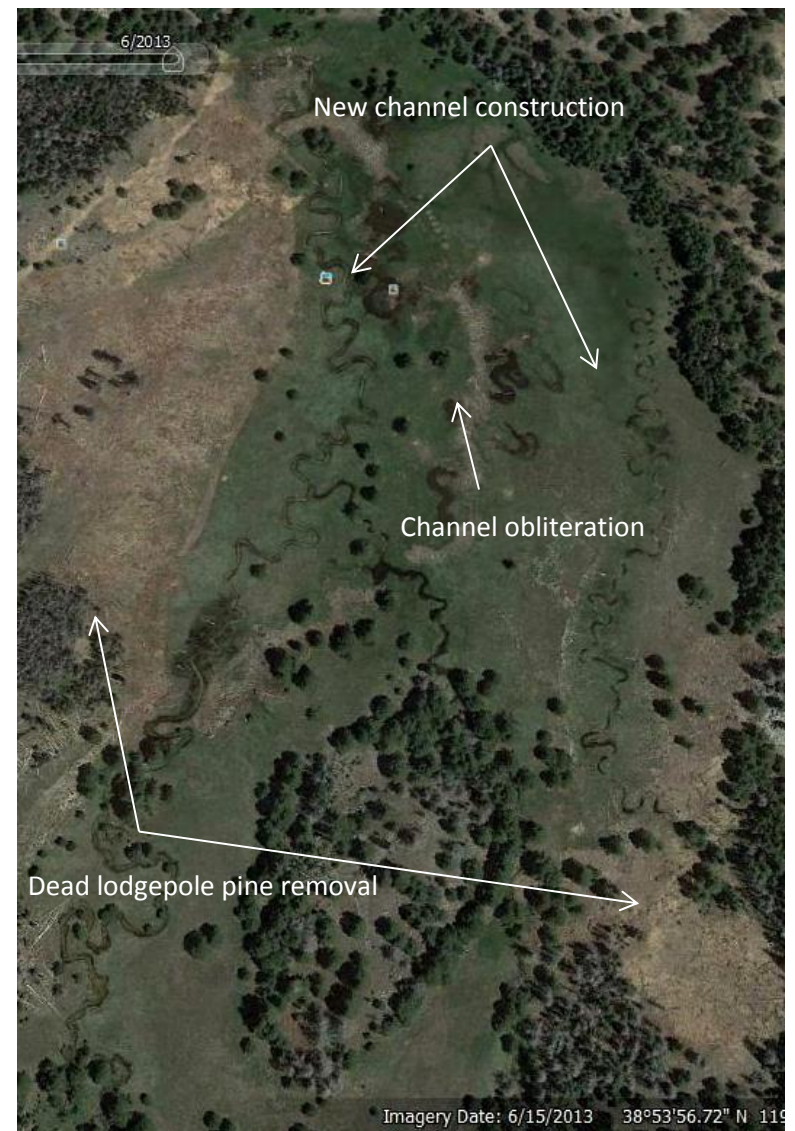
Figure 3: Google Earth Imagery of restoration actions at Cold Creek in High Meadows.

The google earth images provided in Figure 3, from 2010 and 2013 provide a visual representation of the end result of restoration actions.

Sinuosity was calculated using google earth imagery, and is a measure of the degree to which channels meander across the valley floor, derived by dividing channel length by valley length. The google earth images used for measurements are displayed on Figure 3. For stable meadow channels, desired sinuosity is anything greater than 1.5. Measures sinuosity decreased from 2.1 to 1.7 when comparing the old main channel to the new main channel, but the new channel sinuosity is still within the desired range of greater 1.5.

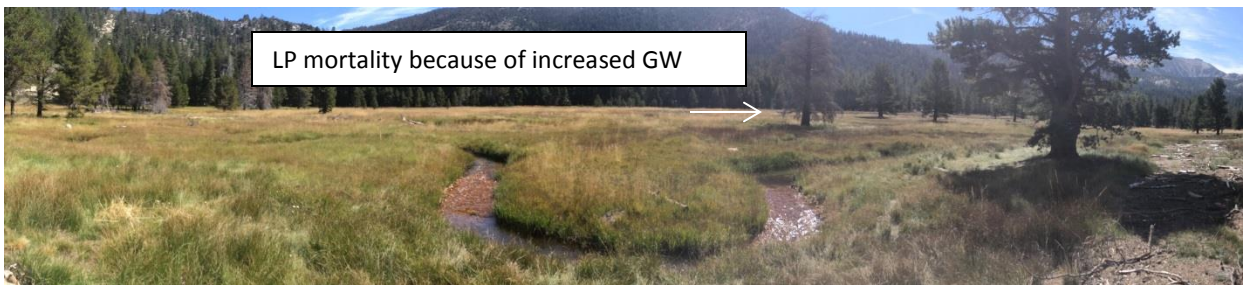
Well 1- Panorama 1, September 2014

Transect 1, (lower portion main meadow, wells 1 through 4). All wells show a reduction in depth to groundwater, between before and after project comparisons of similar precipitation years. Groundwater levels near well 1 increased by two to three feet, bringing levels close to the range needed for riparian/meadow plants. Groundwater levels in wells 2, 3 and 4 were already above the desired 4 foot level prior to restoration, but post- project groundwater levels were increased by an approximately additional 0.5 foot, perhaps benefitting species that prefer very wet conditions.

LP mortality because of increased GW

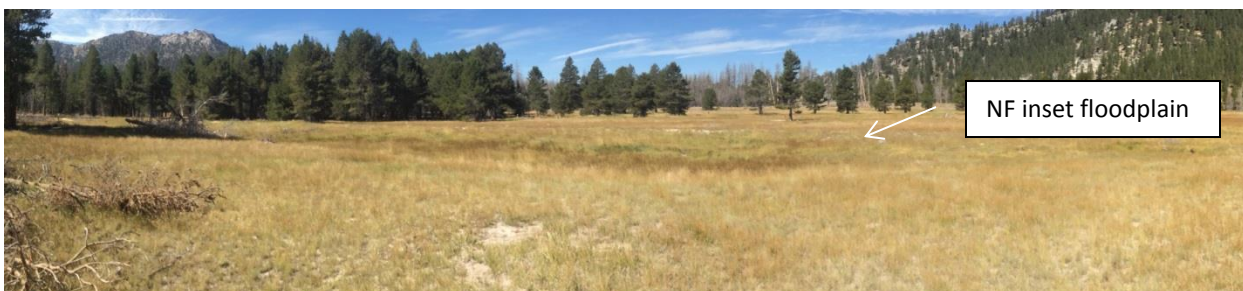
Well 5 -Panorama 5, September 2014

NF inset floodplain
